CO-Gas Safety Unintentional Carbon Monoxide Poisoning Case Study

TANYA & PAUL GARSTANG, Survived in 2020

Appliance & Location: Brand new grill cabin in their garden

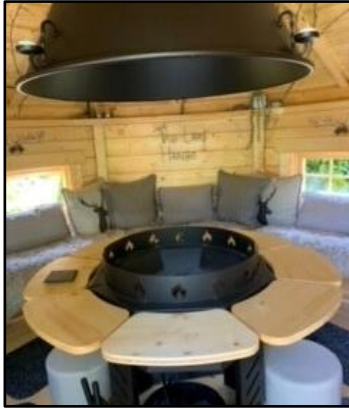
An example of a grill cabin
