## CO-Gas Safety Unintentional Carbon Monoxide Poisoning Case Study

### **RICHARD ASHBY, Survived in 2021**

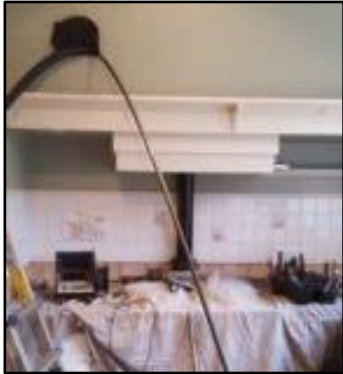
*Sweeping the Ashby's chimney*

Mr Ashby called a pest control firm to make the wasp nest safe. He had not had the Aga chimney swept in 20 years and when Avondale subsequently returned to clear the nest they removed three buckets of material from it. It emerged that the blockage was originally a bee's nest that had been invaded by wasps. Once the chimney had been cleared the CO alarm display returned to 0ppm.
